An Investigation into Failure of Starter Solenoid Spring

Abstract

The Plunger return spring of Starter Solenoid is prematurely failed during service. The said failure is presumed to be associated with the combined effects of wear, cold drawn micro crack and tool mark formed during the service. In-order to understand the cause of the failure, the present paper aims to investigate the spring failure at 203k cycle, by Chemical analysis, Scanning Electron Microscope and Vickers hardness assessment. The test reports from the above said assessments disclose surface irregularities and does not show any noticeable change in chemical composition and hardness. The studies reveal that, the wear scratches are formed due to non-uniform contact of plunger components, which cause the surface crack in the internal dia of the spring. Further, Oxide inclusions act as crack initiation sites, where Crack initiation and propagation route are clearly observed in the Scanning Electron Microscope images. This paper, further discusses the methods to improve the spring life.

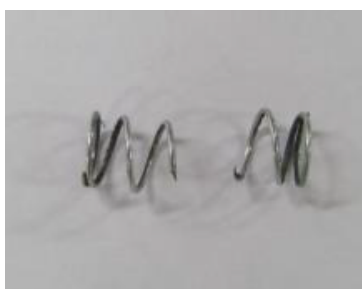
Figure 3b: Failure spring.

The spring is manufactured from the material called steel wire Music spring ASTM A228. The property of the material is to withstand the temperature ranging from -150°C to 200°C. The plunger spring used in solenoid and its failure configuration is shown in Figures 3a and 3b. In order to prevent the material from oxidation and corrosion during elevated (high) temperature, it is subjected to Zinc electroplating. For visual examination the sample is cleaned with acetone, which is done prior to metallographic inspection. Then, the fractured surface of the spring is analyzed using Scanning Electron Microscope. The samples are prepared from the fractured spring for microstructural analysis, which are further polished and etched with 2% nital reagent (2 ml

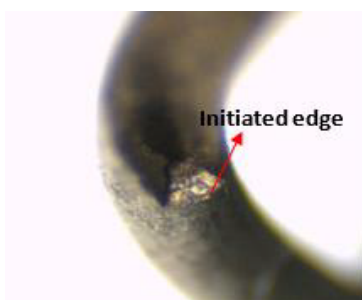
Figure 4a: Fracture edge crack initiation.

The Fracture edge and crack initiation location is shown in Figure 4a. From the Figure 4b, it is evident that, the samples possess visible tool mark and deep scar, which also shows the crack initiation point. The fracture edge is extended at an angle of 45° on one side of the wire axis and the other side extending half way through the wire thickness following the tool mark. The crack grows as spiral around the axis surface, which is typically known as torsional fatigue as shown in Figure 4c [3-5].

The fatigue origin is identified at the inner surface of the active coil, which is occurred due to contact and friction of inner surface of the spring with plunger. The material of the plunger and spring is designed

to withstand the contact wear to improve the life. But, the irregular flattened surface of the spring and non-uniform contact of plunger and spring, creates stress singularity and high friction at particular location [5]. The fatigue crack originated at rubbing surface of two mating parts, where the wear scar and high stress are experienced.

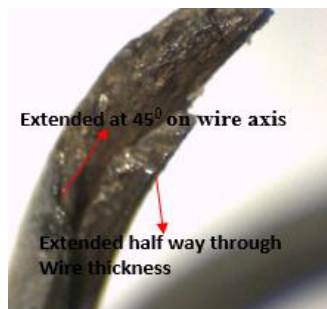
Figure 4c: Crack propagation.

1. Fatigue failure occurred in the spring is by the combined effects of wear, tool mark and corrosion pits associated with stress singularities at the contact surface of inner coil surface and plunger.
2. Once the crack initiated, it is propagated to core with direction of 45° to the tensile axis of the wire.
3. The crack is propagated by the force of maximum compressive stress.

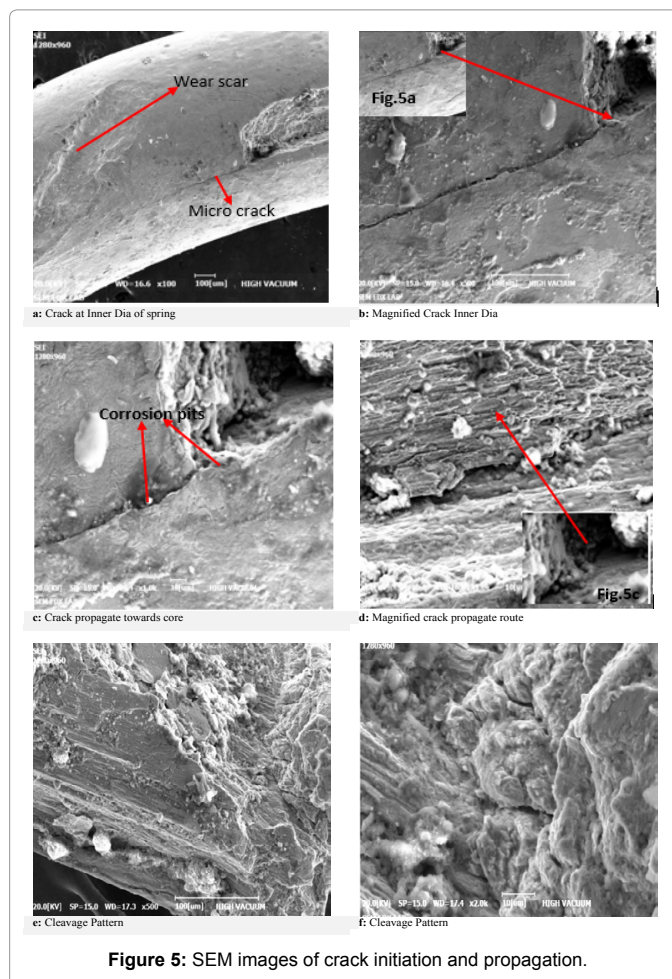
Figure 5: SEM images of crack initiation and propagation.

Wear Scar and Micro crack are observed at inner surface of the active coil of the spring as in Figure 5a, the wear scar and the crack propagation path act as stress raiser resulting in catastrophic failure. It is confirmed that, the spring and plunger had non-uniform contact and experienced vigorous deformation. The crack is continued to propagate to the core in the direction of inner coil dia towards midway of the wire center as shown in Figure 5b and 5c. The crack might have elevated to the core instead of the surface because of some oxide inclusion at path of propagation. It is exemplified by the deep pull out of surface Figure 5c. From the core, the crack propagates in both longitudinal and radial direction as shown in Figure 5d.

It is observed that, all region of fracture have cleavage patterns, which confirms that, the material failed in intergranular brittle manner as in Figure 5e and 5f. In case, if it would have been due to ductile failure, the samples must have shown ductile dimple pattern, instead of cleavage pattern [6]. The crack initiated deforms the surface of protective layer, which led the elements to oxidize and experience corrosion. Corrosion pit is observed at crack tip as shown in Figure 5c, which is the reason for crack elevation towards core.

4. It is strongly recommended to have uniform contact between spring and plunger in order to avoid stress singularities and frictional wear.
5. The materials should be treated for secondary process to improve the wear resistance and to reduce the surface integrity.
6. The flattened level in closed end of the spring and flattened

surface required for spring base, plays an important role in stress singularities and frictional wear.
