Disastrous Events on Kelash-Mansarowar Route, Dharchula Tehsil in Pithoragarh District, Uttarakhand in India

Sushil Khanduri*, Sajwan KS and Ashish Rawat
Disaster Mitigation and Management Centre, India, E-mail: sushil.khanduri@gmail.com

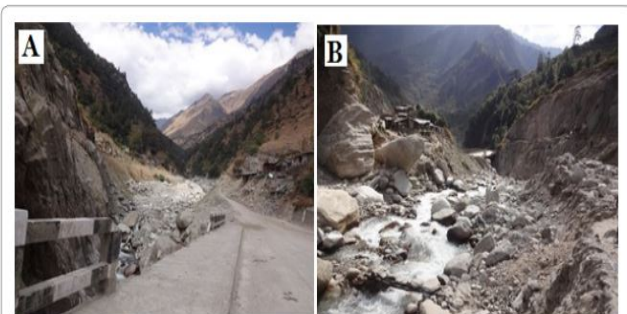
Going to the Border Post Army persons were camped near Mangti area on the left bank of Simkhola Gad on 13 August, 2017. They were also parked their vehicles on the road and bridge at the same place. According to the local people, at early morning (2:30 am) high flash flood discharge of the Simkhola Gad contributed to the instability of the hill slopes of the Mangti area. The course of this gad was temporary blocked and water saturated debris overran the bridge, road and other structures. Around 50 meters road was washed off while barricading of bridge was also damaged in this incidence (Figure 2a). A number of places upstream to bridge around 2-3 meters thick pile of sediments were deposited on the right bank of Simkhola Gad (Figure 2b). The deposited sediments

were observed to comprise of debris consisting of grey, fine grained silty matrix with rare boulders and fragments of schist and gneiss. As many as 9 persons were killed in this incidence. Of these bodies of 08 could not be recovered. Total of 3 Army tents and 2 vehicles were damaged and 51 cattle were lost. Because of loose soils/overburden and low level, damage or destruction mostly occurred along the left bank. Besides flash flood, landslides are also observed on the downhill and uphill side to devastated area along the road section.

Figure 2: (a) Damaged barricading of bridge together with eroded road at Mangti area due to stream erosion by Simkhola Gad, (b) Accumulated sediments on the right bank of the Simkhola Gad.

- It is suggested that appropriately designed bank protection walls should be constructed along the Simkhola Gad at Mangti area where road was washed off by stream. This practice will protect the road as well as bank of Simkhola Gad from stream erosion. Besides, damaged barricading of exist bridge should also be repaired.
- In the future, existing bridge of Mangti also needs to be relocated to upstream. This would protect the road along with left abutment of Bridge from the threat of flash flood.
- It is suggested that reconstruction of washed off pedestrian trek and bridge around the Malpa area. Alternative connectivity options, such as rope-ways would be better suited for the hills.
- In future recurrence of extreme rainfall events cannot be ruled out and therefore development like temporary camps, tourist camps and realignments of hazardous routes should be needed in safer location.

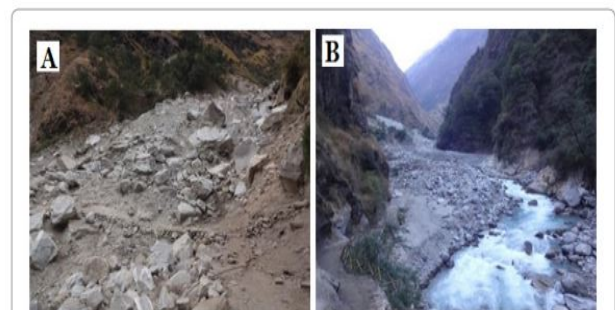
by efforts taken to create a vacuum at back side as per On the same day, flash flood incidence took place at Malpa area in Pithoragarh district. Some of the habitation was situated over the old landslide mass and close to Malpa Gad at bottom of the hill slope. The excessive stream water eroded the old landslide mass on the left bank. The vertical height of the eroded cut is around 8-10 meters and

width along the gad is around 120 meters. The overburden materials were observed to comprise of debris consisting of grey, fine grained silty matrix with rare boulders and fragments of quartzites. The pedestrian route leads to Kailash-Mansarover together with bridge were washed off in this incidence. Gully erosion is to be largely responsible for the devastation in the area (Figure 3a). As many as 8 persons were died and 10 persons went missing while 4 shops were damaged due to water saturated debris flow in the eastern side to Malpa gad area. As also, due to fast pace of stream water, sediments have been dumped at various places along the Kali river banks just downstream to affected area (Figure 3b).

Figure 3: (a) Gully erosion in the old landslide mass on the left bank of Malpa Gad, (b) accumulated sediments along the Kali river banks in the area round Malpa.
