Forest Range Strong Room Robbery Case: Examination of Lock and Gas Cutter Tool Marks – A Case Study

Abstract

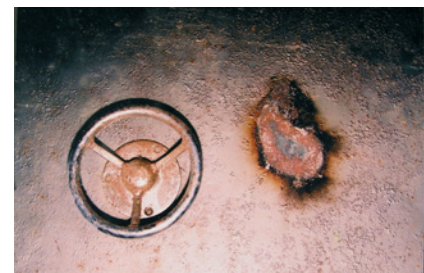
Figure 3: Strong room door with the steering wheel.

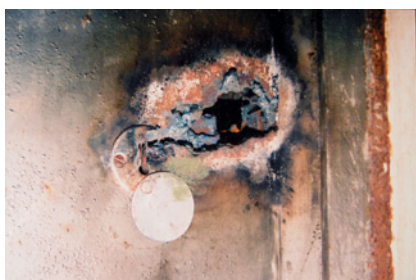
For query no.1 the keys were inserted into the key hole of the lock (Figure 7, 8) and operated. It was found that the keys could not be turned as a portion of the lock is damaged due to gas cutting (Figure 4, 5). Also the keys were observed microscopically, no usage marks were found on the key.

Figure 4: Strong room door with the steering wheel.

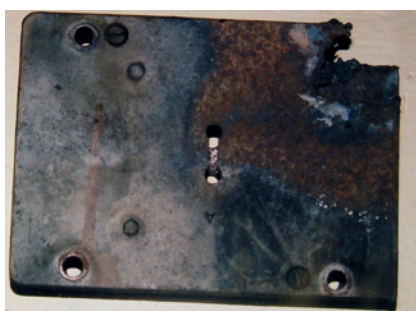
Figure 5: Strong room lock with levers inside.

For query no.2 the continuity of the melting metal was observed on the lock (Figure 5, 6). The melting metal of the lock showed continuity and no dislocation of metal or melted metal was observed and the top lever was drawn inside. Hence it can be inferred that the lock was in unlock condition.

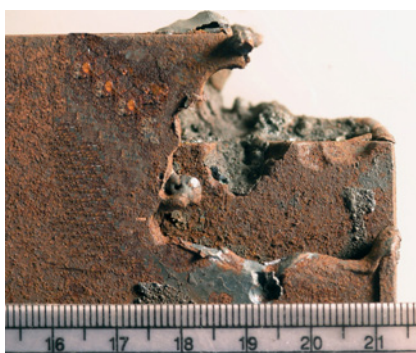
Figure 6: Part of the lock damaged.

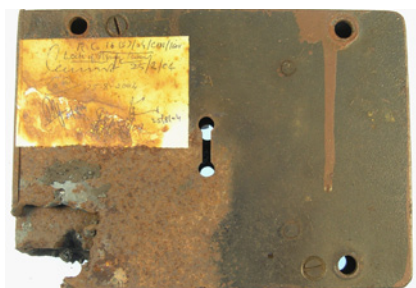
Figure 7: Strong room lock.

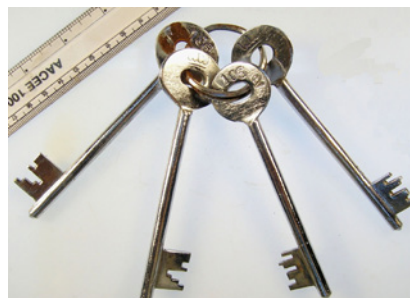
Figure 8: Strong room keys.

The examination of the lock and keys showed that the keys cannot be operated into the lock in the present condition. The position of the levers in the lock suggests that the lock was in unlocking position. Based on the microscopic and visual comparison of the tool marks [1,2] formed on the strong room doors and the control gas cut marks, it could

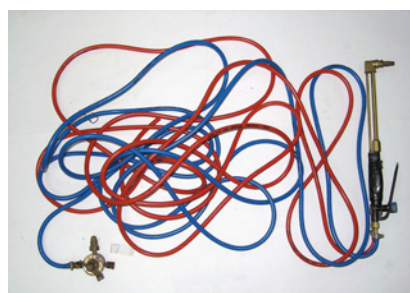
Figure 9: Seized gas cutter.

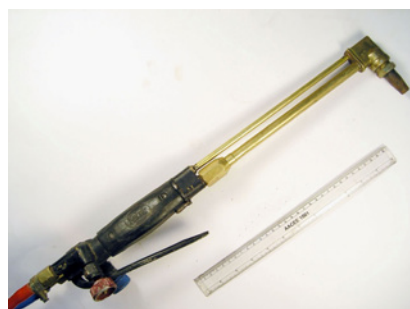
Figure 10: The nozzle of the gas cutter.

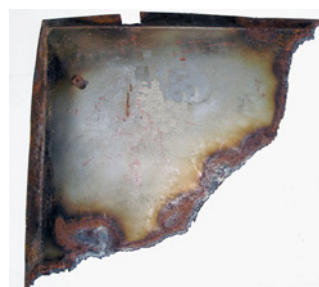
Figure 11: One of the pieces of the strong room door.

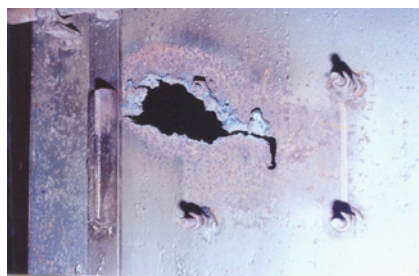
Figure 12: Gas cut marks on the strong room door.

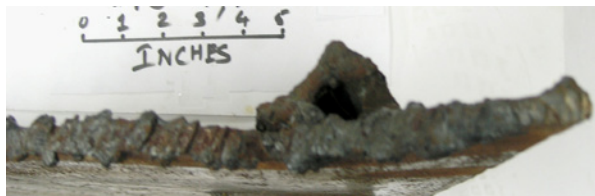
For query no.3 the gas cut marks found on the strong room doors and the control gas cut marks (Figure 13, 14, 15) forwarded were

observed visually and microscopically [1,2]. The characteristic features of the tool marks and the beading formed due to melting of the metal found on both were compared.

Figure 13: The gas cut tool marks on the piece of the strong room door.

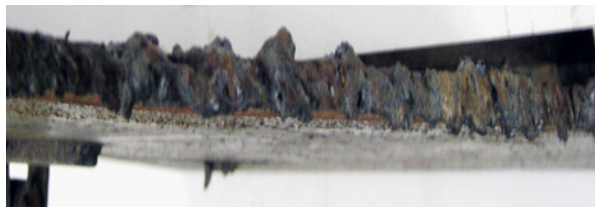
Figure 14: The gas cut tool marks on the piece of the strong room door.

be opined that the strong room was cut using a gas cutter. No external force other than the gas cut marks were found on the lock. Also it could be opined whether the cut was made from inside or outside clearly from the beading formation on the sheets.
