An Investigation into Failure of Starter Solenoid Spring

Abstract

The Plunger return spring of Starter Solenoid is prematurely failed during service. The said failure is presumed to be associated with the combined effects of wear, cold drawn micro crack and tool mark formed during the service. In-order to understand the cause of the failure, the present paper aims to investigate the spring failure at 203k cycle, by Chemical analysis, Scanning Electron Microscope and Vickers hardness assessment. The test reports from the above said assessments disclose surface irregularities and does not show any noticeable change in chemical composition and hardness. The studies reveal that, the wear scratches are formed due to non-uniform contact of plunger components, which cause the surface crack in the internal dia of the spring. Further, Oxide inclusions act as crack initiation sites, where Crack initiation and propagation route are clearly observed in the Scanning Electron Microscope images. This paper, further discusses the methods to improve the spring life.

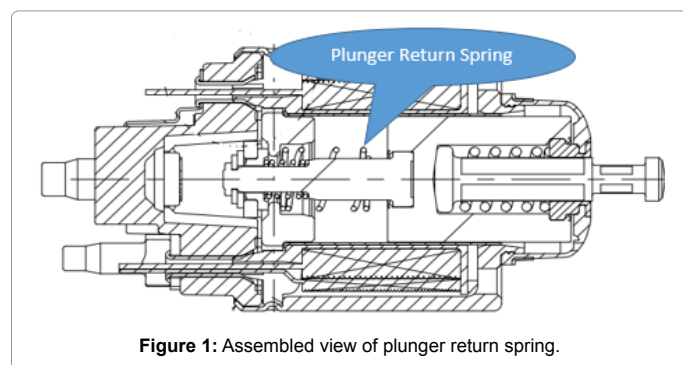
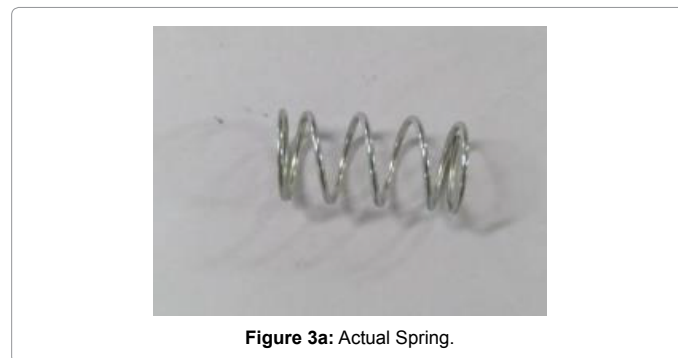
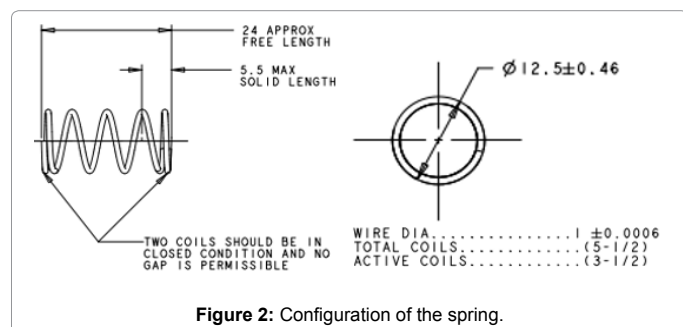
The spring is manufactured from the material called steel wire Music spring ASTM A228. The property of the material is to withstand the temperature ranging from -150°C to 200°C. The plunger spring used in solenoid and its failure configuration is shown in Figures 3a and 3b. In order to prevent the material from oxidation and corrosion during elevated (high) temperature, it is subjected to Zinc electroplating. For visual examination the sample is cleaned with acetone, which is done prior to metallographic inspection. Then, the fractured surface of the spring is analyzed using Scanning Electron Microscope. The samples are prepared from the fractured spring for microstructural analysis, which are further polished and etched with 2% nital reagent (2 ml

Figure 3b: Failure spring.
